# Manhole Inspection Summary

Manhole # S39I\_\_016MH

Insp Date: **3/27/08 1:51 PM**

**Location** Address: **800 fawn st**

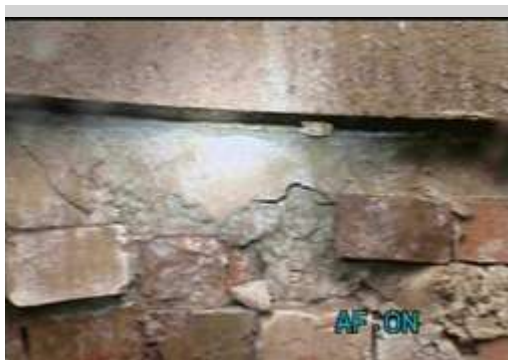
Defect 3

Condition: ☐ Sound ☐ Cracked ☐ Root Intrusion ☐ Loose Brick ☒ **Deteriorated**

chimney/corbel deteriorated

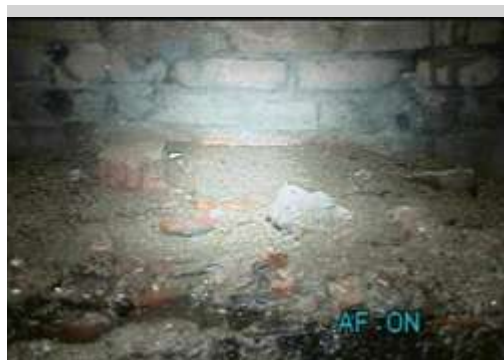
Defect 2

Condition: ☐ Sound ☐ Cracked ☐ Root Intrusion ☐ Deteriorated ☐ Leaks ☒ **Debris**

bench debris

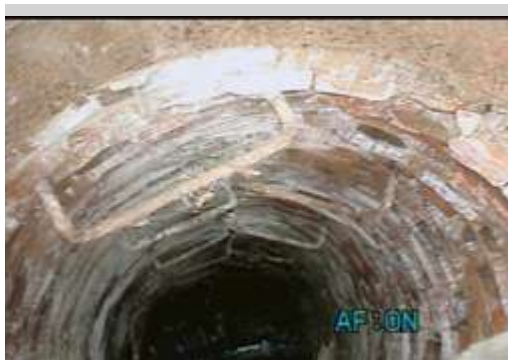
Defect 1

**Steps** Count: **10** Missing: **0** ☒ **Corroded**

steps

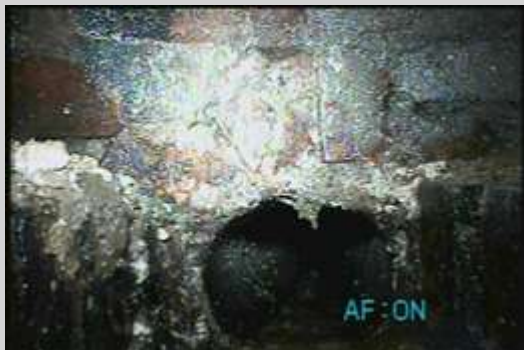
12 O'Clock Outflow

Pipe Height: 0 (in.) Direct  
Pipe Material: **Clay** ☐ Pipe Lined  
Invert Depth: **15.96** (ft.) Flow Characteristics: **Slow**  
Deposits: ☐ None ☐ Mud ☐ Sludge ☒ **Debris** ☐ Grease  
Silt Depth: 2 (in.) Deposits Extent: **Light**  
Infiltration: **None** Pipe Seal Cond: **Unknown**

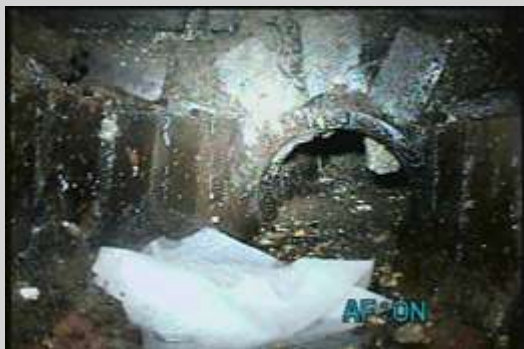
7 O'Clock Inflow

Pipe Height: 0 (in.) Direct  
Pipe Material: **Clay** ☐ Pipe Lined  
Invert Depth: **15.46** (ft.) Flow Characteristics: **None**  
Deposits: ☐ None ☐ Mud ☐ Sludge ☒ **Debris** ☐ Grease  
Silt Depth: 4 (in.) Deposits Extent: **Medium**  
Infiltration: **None** Pipe Seal Cond: **Unknown**

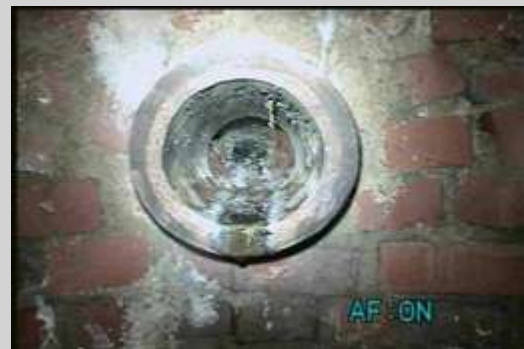
Drop In @ 7 O'Clock

Drop: **Outside Direct**  
Angled: Reading: **0.00** (ft.)  
Inv Depth: **15.88** (ft.)

Drop Condition: **Partly Clogged**
